From: [Denise Charlebois](#)
To: [Camille Leung](#); [Planning Commission](#); [Timothy Fox](#); [Steve Monowitz](#); mhaesloop@chsdg.com; [Gregory Smith](#); [Heather Forshey](#)
Subject: 634 Palomar Dr. PLN2020-00251 June 21 Planning hearing D. Enea
Date: Thursday, June 15, 2023 3:02:47 PM
Attachments: [D.Enea Planning Commission 6-21-23.pdf](#)
[223016 Wet Season 2023 Effects Letter 20230615Balanced Hydrologis.pdf](#)
[Kilik 6-2023.pdf](#)
[Enviromental Health failed septic 6-2023.pdf](#)
[2022 Arborist report Richard Smith-stating stability of hill in jeopardy.pdf](#)
[Grading violafion 634 Palomar.pdf](#)
[21 Estrada Sewer hookup20080610 letter 051022430.pdf](#)
[Drainage report 738 Loma Ct 4-13-23 GCD Inc .pdf](#)

RE: 634 Palomar Dr. PLN2020-00251

SEISMIC HAZARD MAP
634 Palomar Drive
Woodside, California

**Focused Site Drainage Assessment
738 Loma Court, Redwood City, CA
04/13/2023**

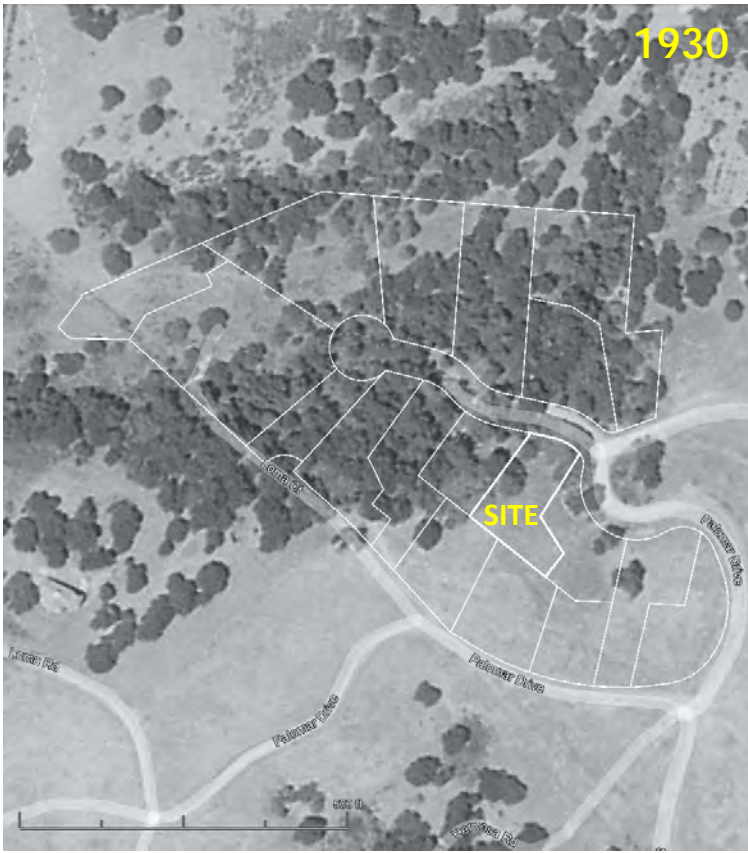
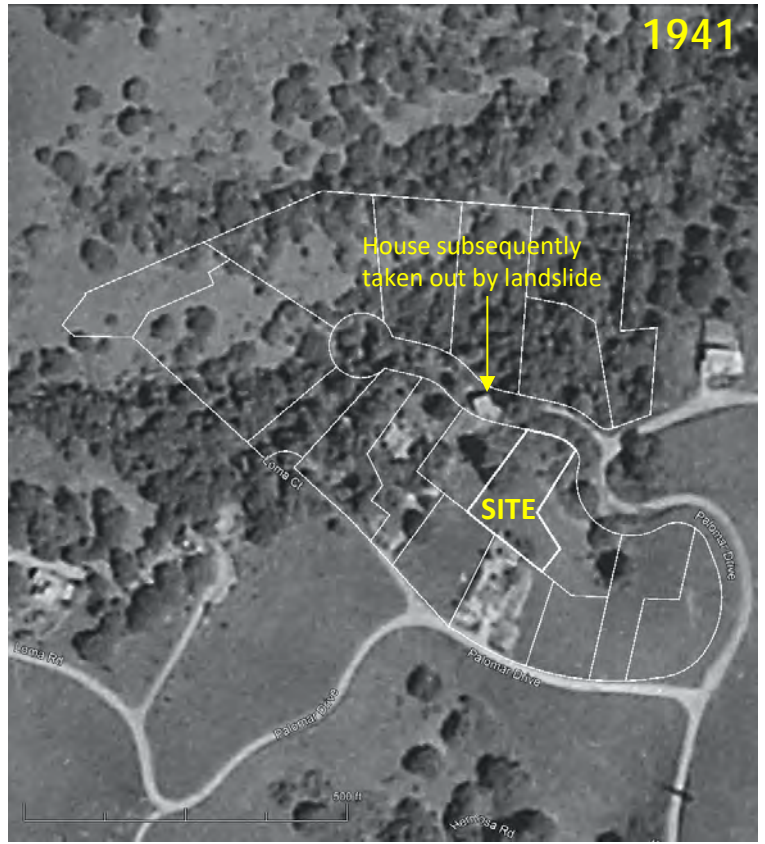
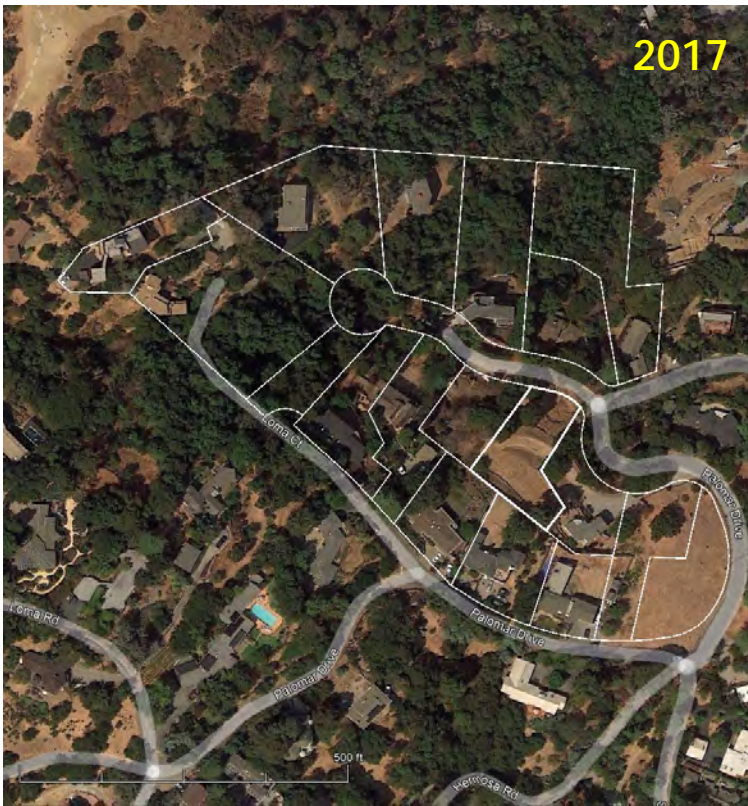
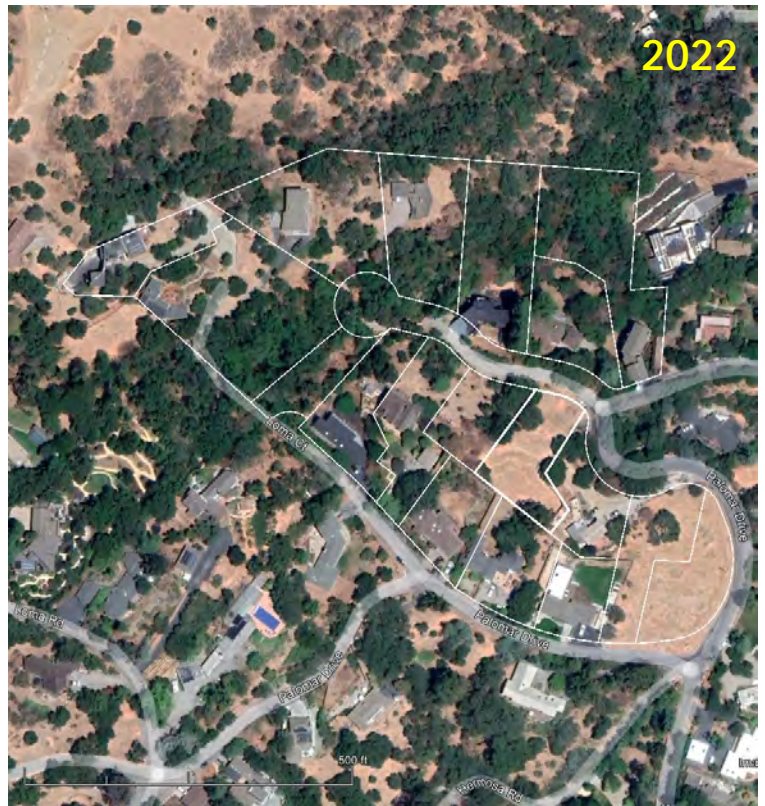
Figure 2. Historical aerial photos show increased home building, tree removal, and landsliding, Los Cerros Rd and Palomar Dr area, San Mateo County, CA. Major landsliding documented during wet years 2017, 1982-83, and 1950s.

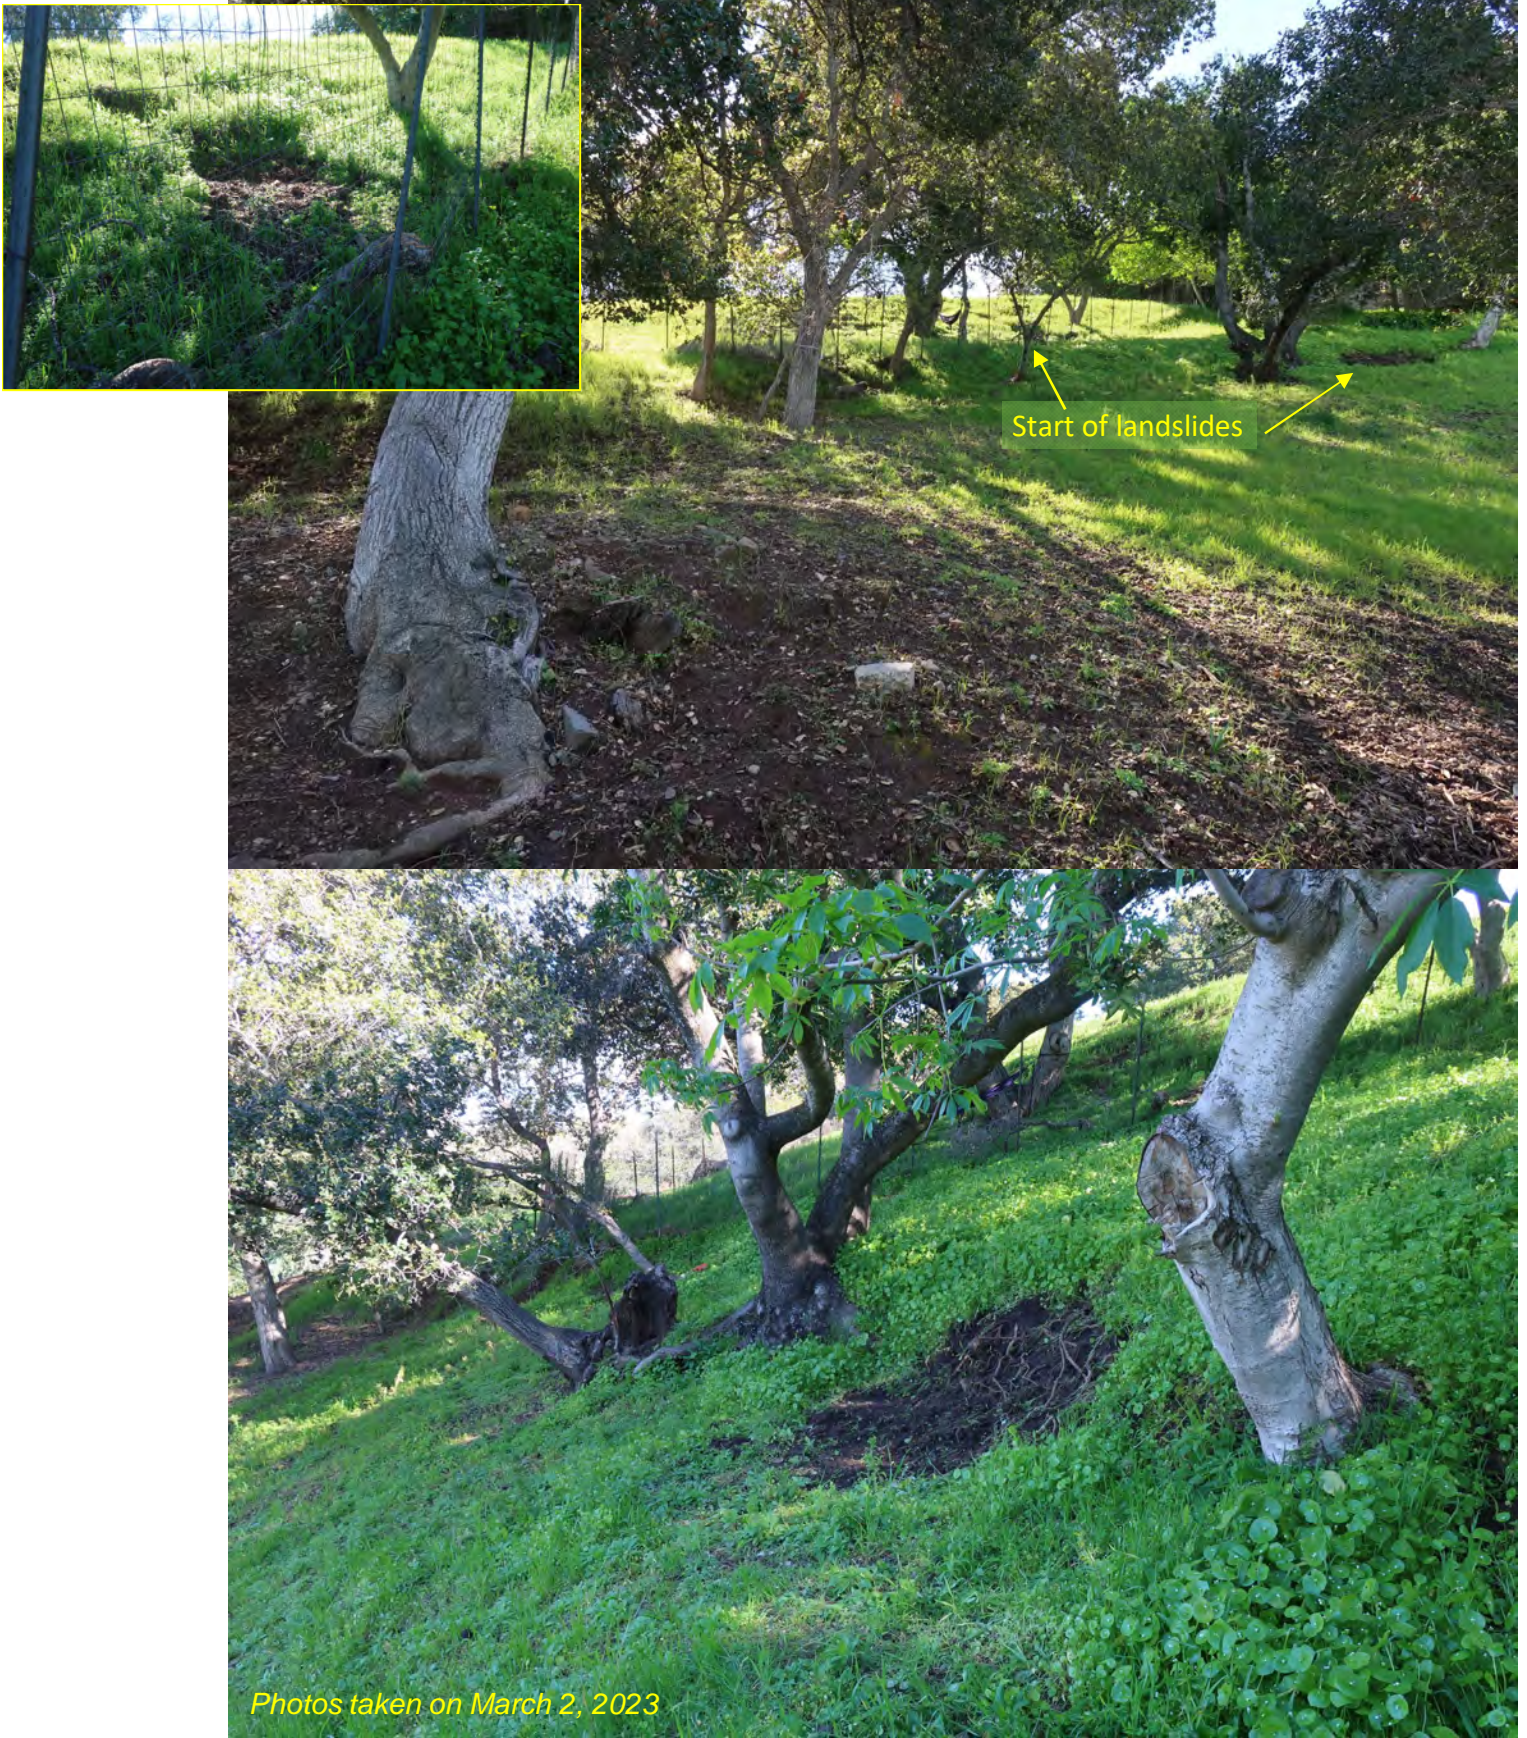
- Information which we believe is not previously noted in the files is the indications of active earth movement at the upslope property line of the Enea parcel (APN 051-022-310). As seen from the Enea parcel, the 10-foot high whitewashed cinderblock retaining wall is bulging outward with up to several feet of displacement. The wall bears fresh, unweathered open cracks of up to ½ to 1 inch wide in what seems to be evidence of at least some recent downslope movement. One of the largest of these cracks is about 30 to 40 feet southwest of end of the proposed expansion leachfield, and within the 100-foot setback from the proposed septic system. The deformed cinderblock wall is readily visible from either the applicant's lot or Ms Enea's.

Figure 3. Photos showing start of new landsliding at the property line of proposed project APN 051-022-380 and adjoining parcel APN 051-022-310, San Mateo County, CA. Note the importance of tree roots along the property line to contain landsliding.

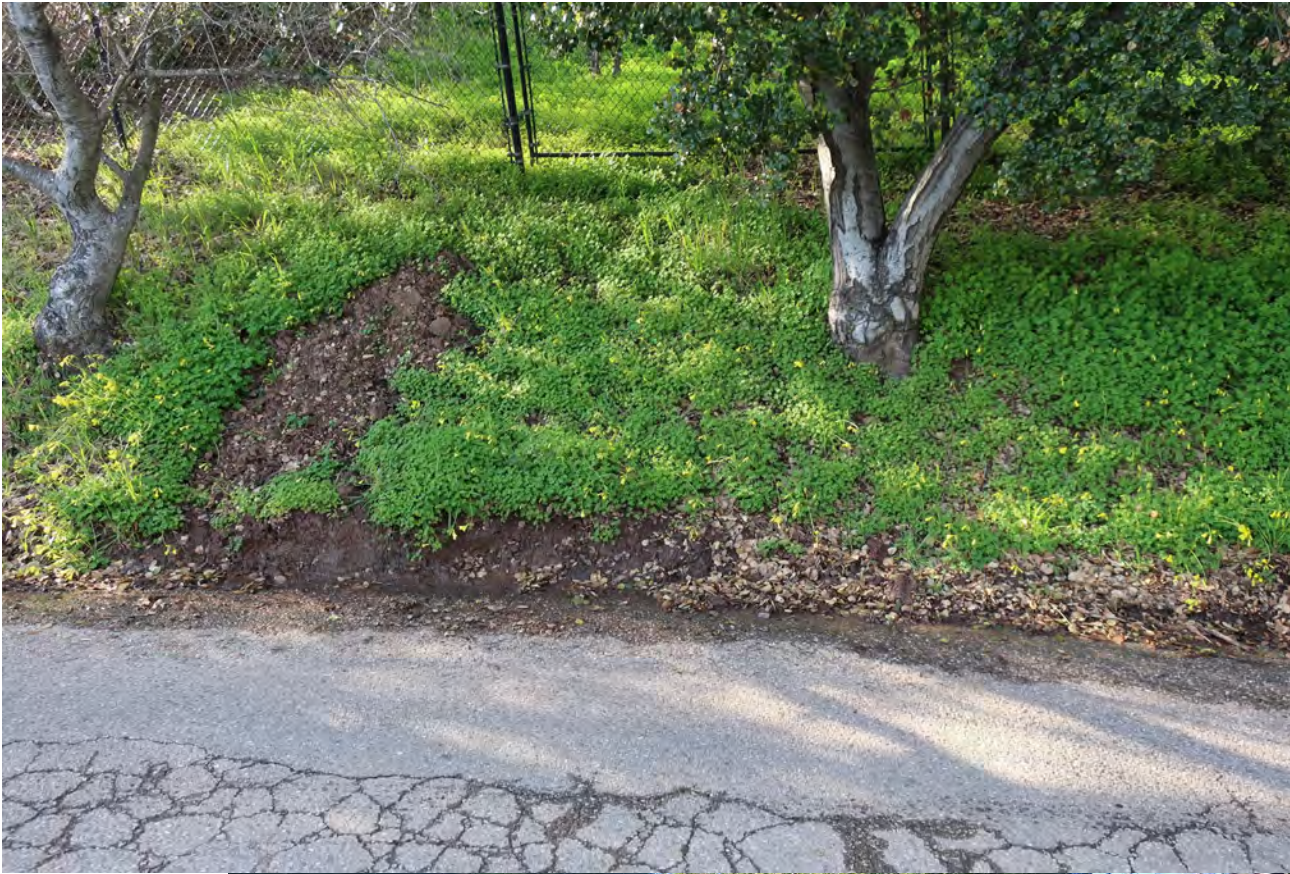
*Palomar Dr
west of Loma
Rd*

Figure 4. Photos of other seeps and slumps along Palomar Dr, San Mateo County, CA. Photos taken on March 2, 2023.

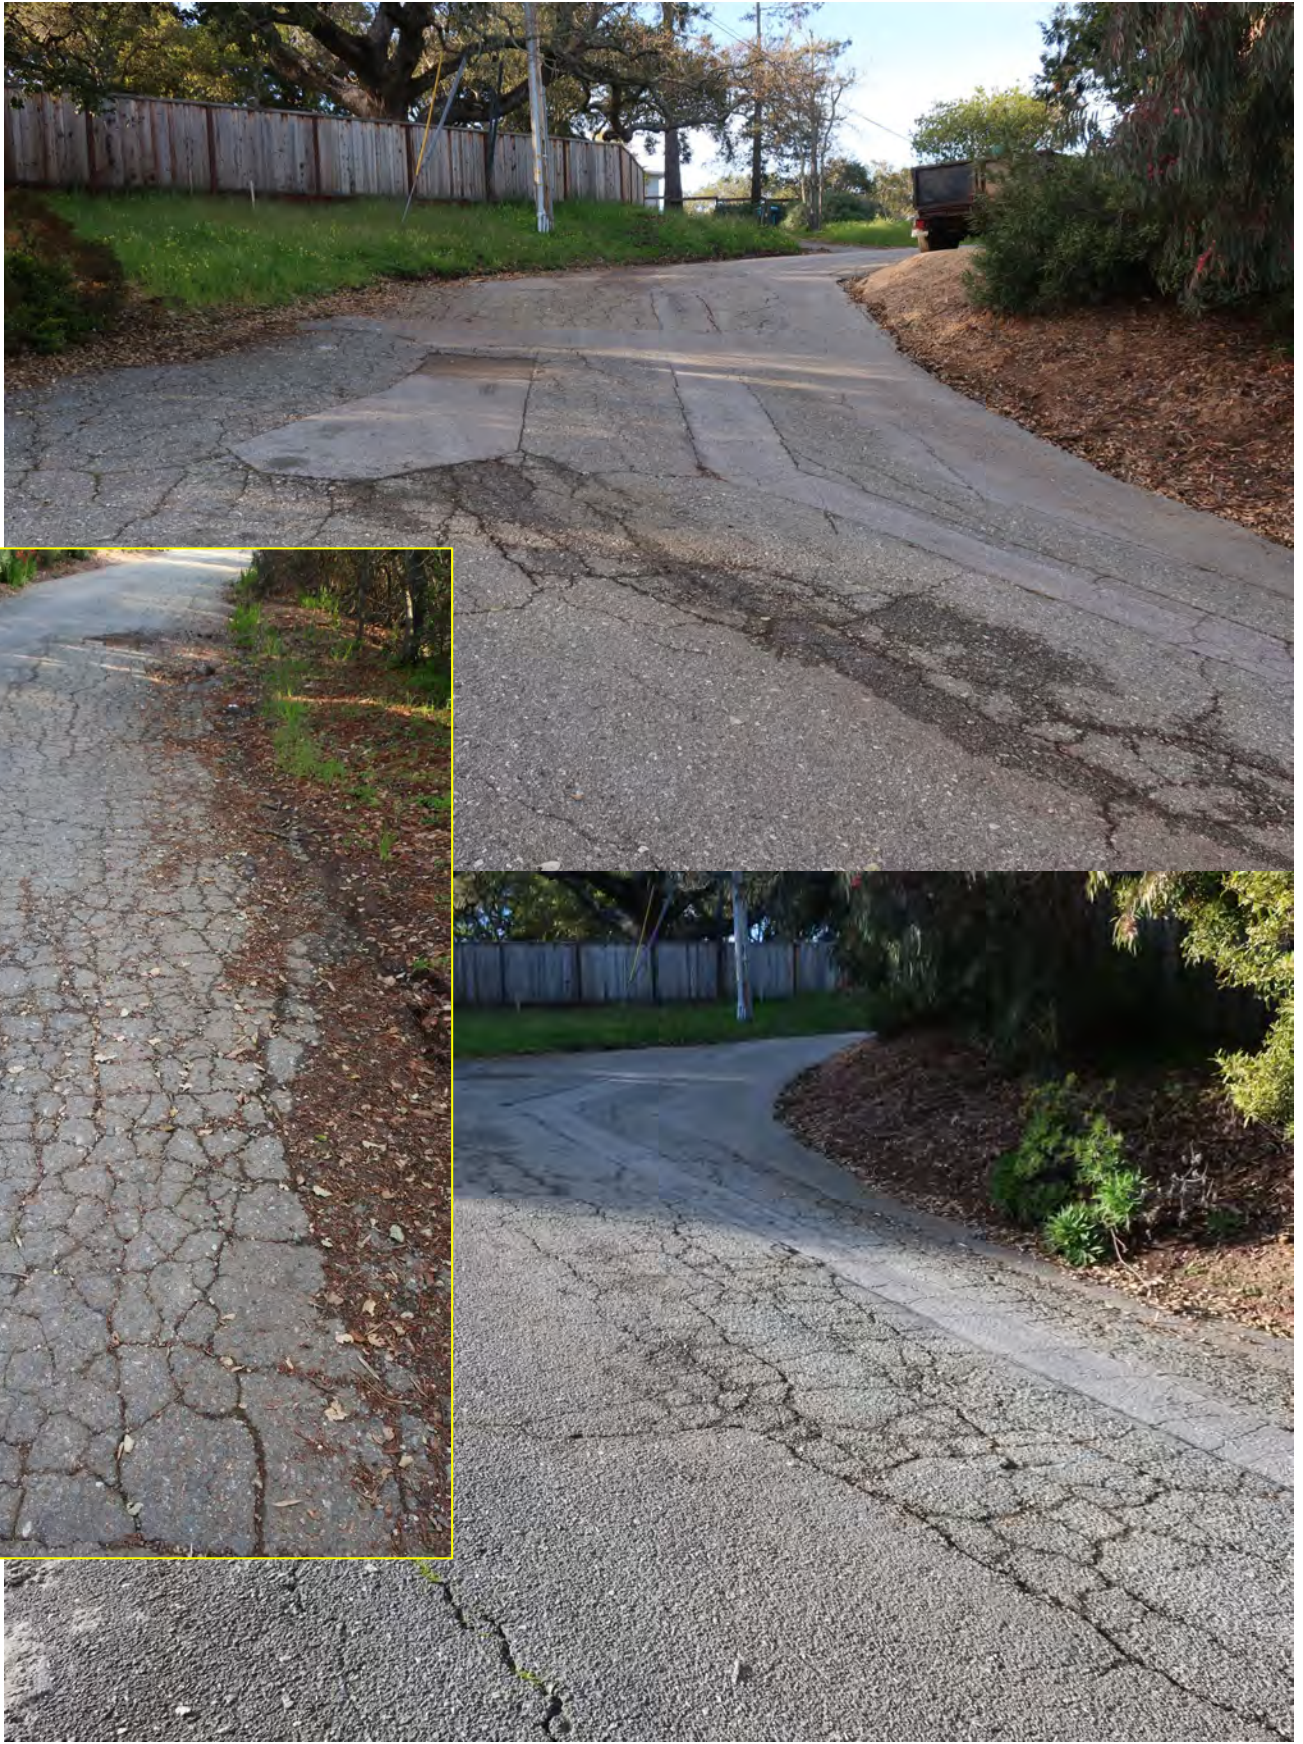
Figure 5. Photos checked and patched asphalt indicating underlying water along Loma Rd, San Mateo County, CA. Photos taken on March 2, 2023.

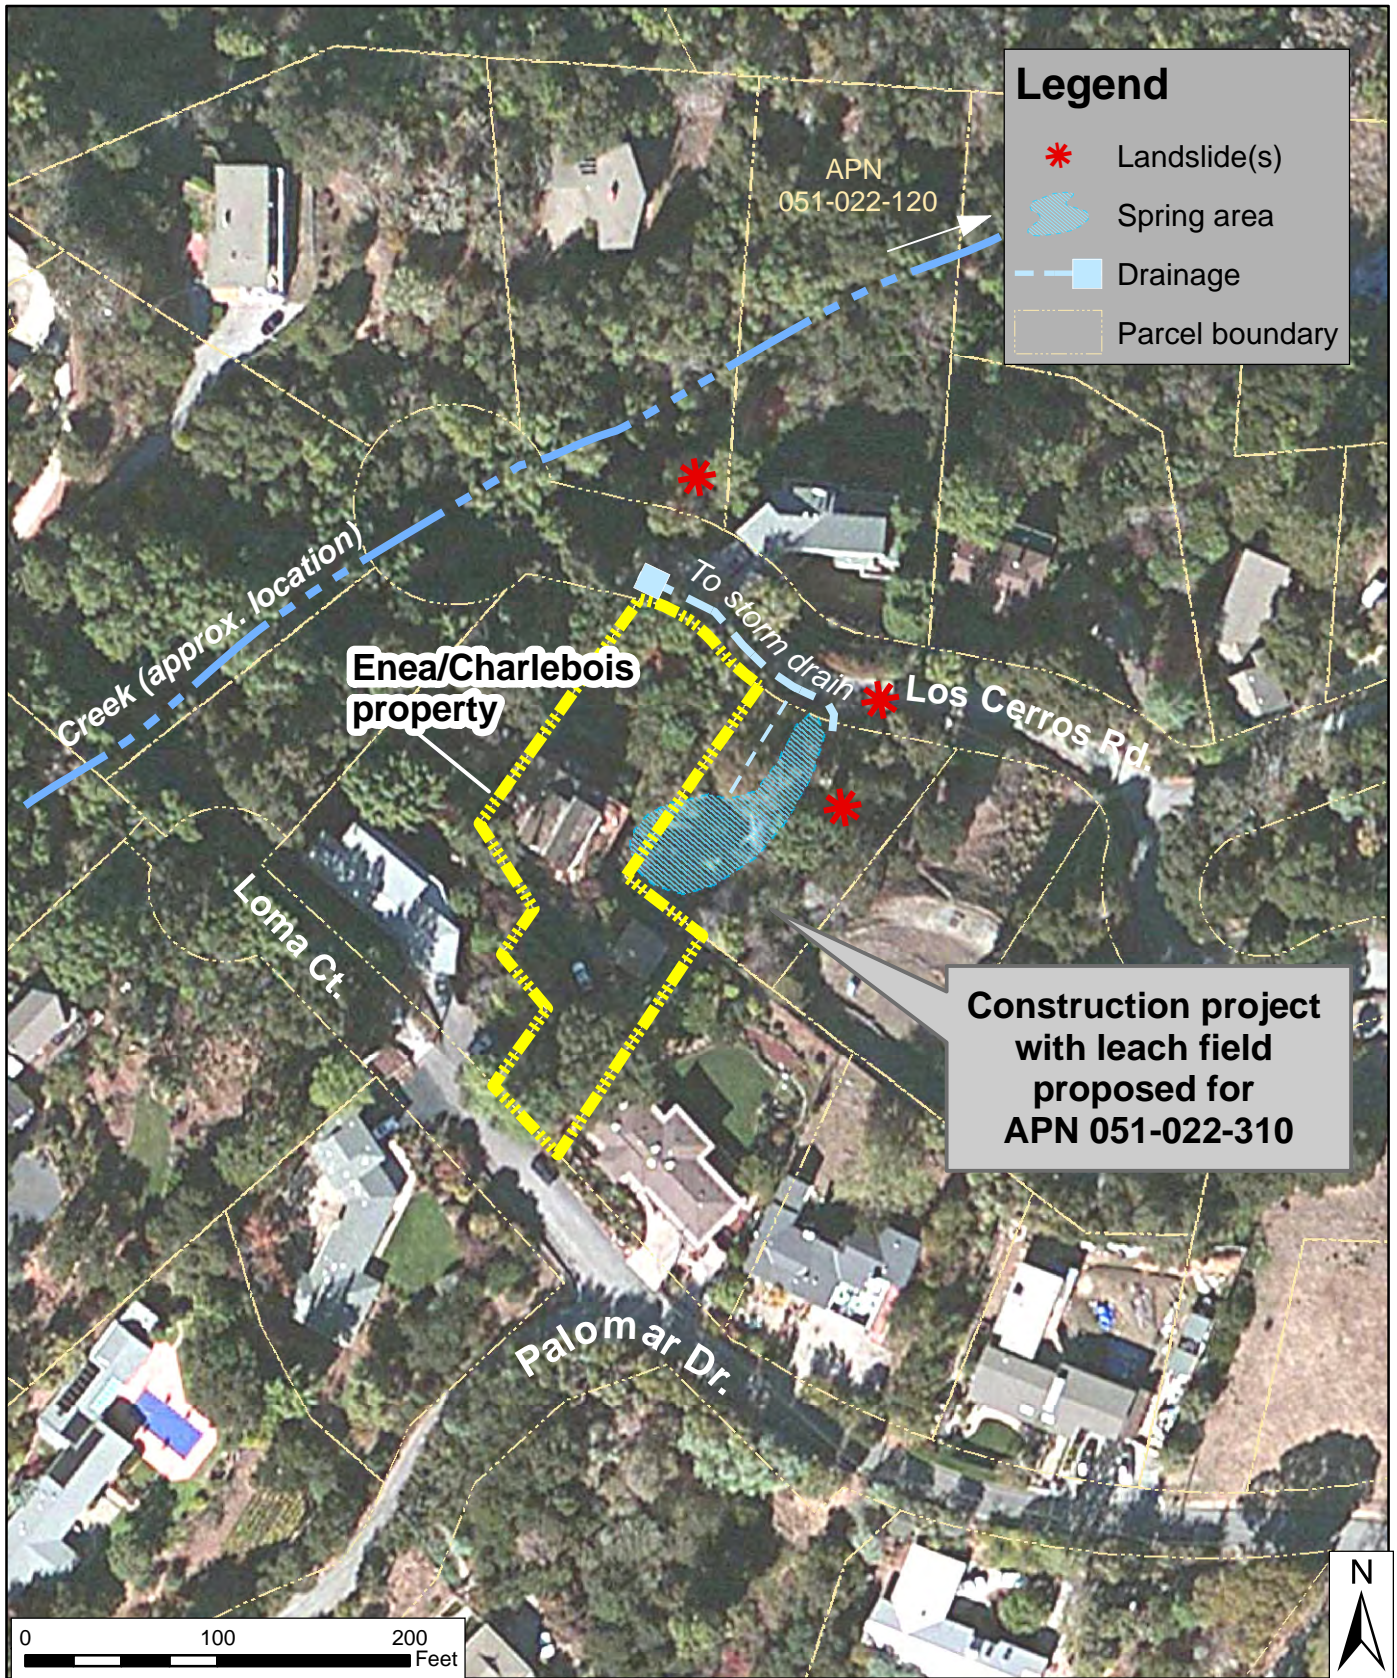
Figure 1. Spring area and historic landslides near the Enea/Charlebois property.

Note: A large spring area and high groundwater is present on APN 051-022-310, adjacent to the Enea property. Several landslides have been documented on this parcel (see Table 1).

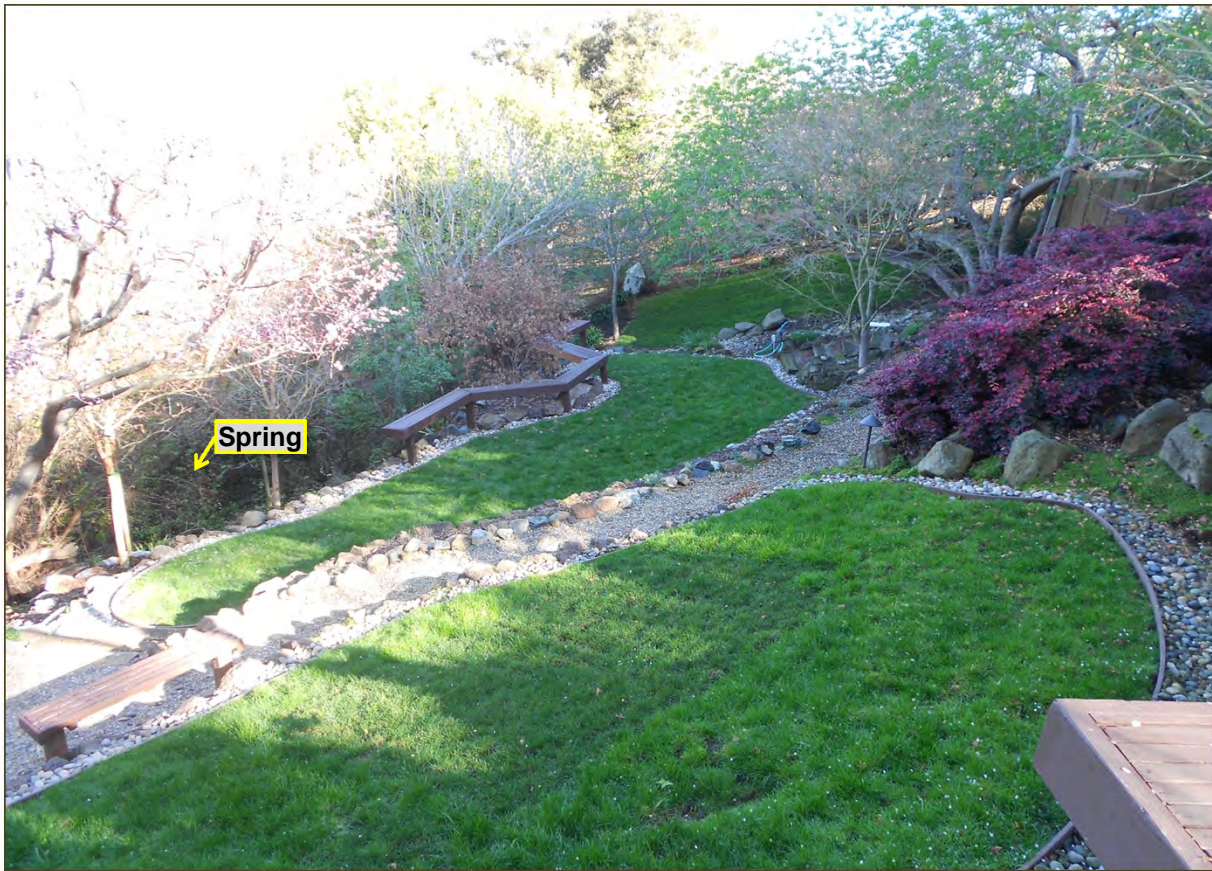
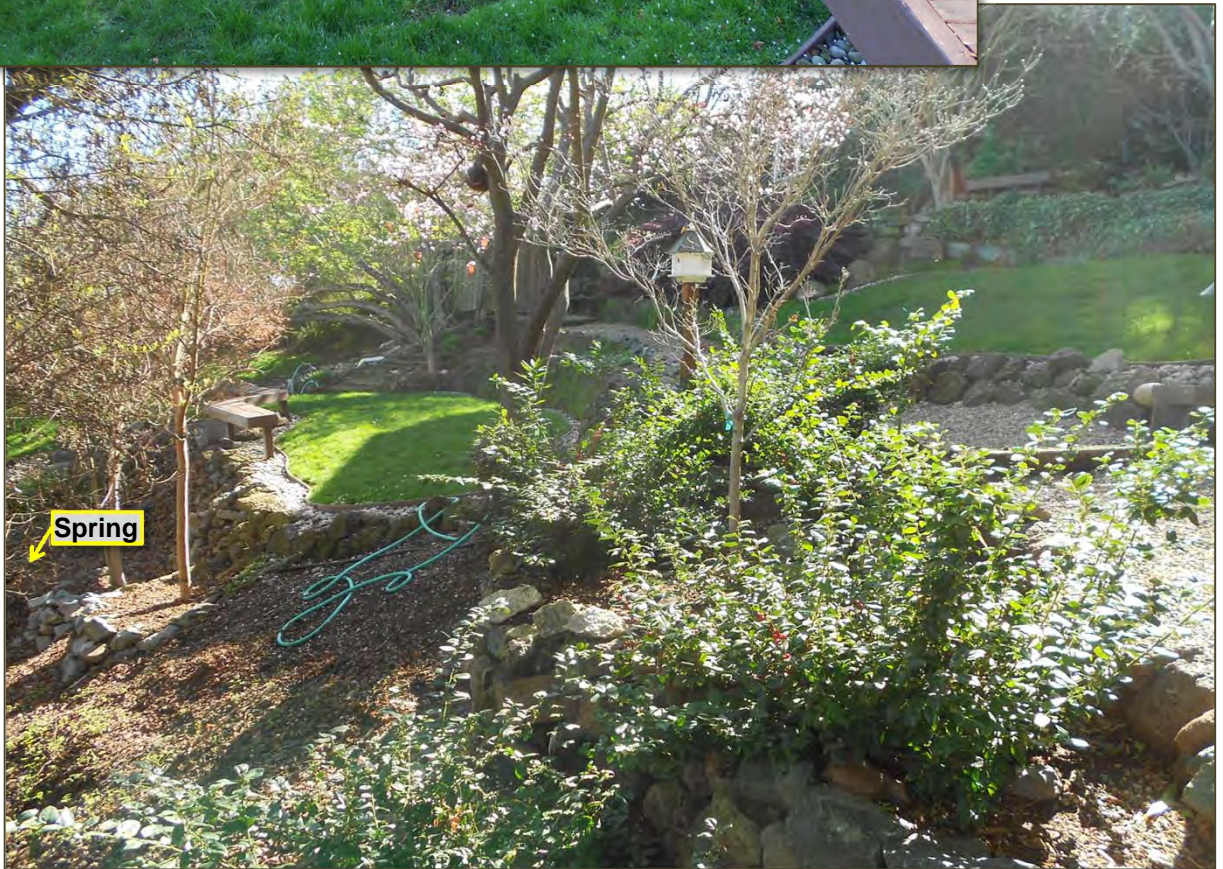
Figure 3. Upper portion of APN 051-022-310, Redwood City, California. Spring discharge starts off the photo, about 20 feet downslope of benched grass area. Photos taken looking east from Enea/Charlebois property, APN 051-022-180.

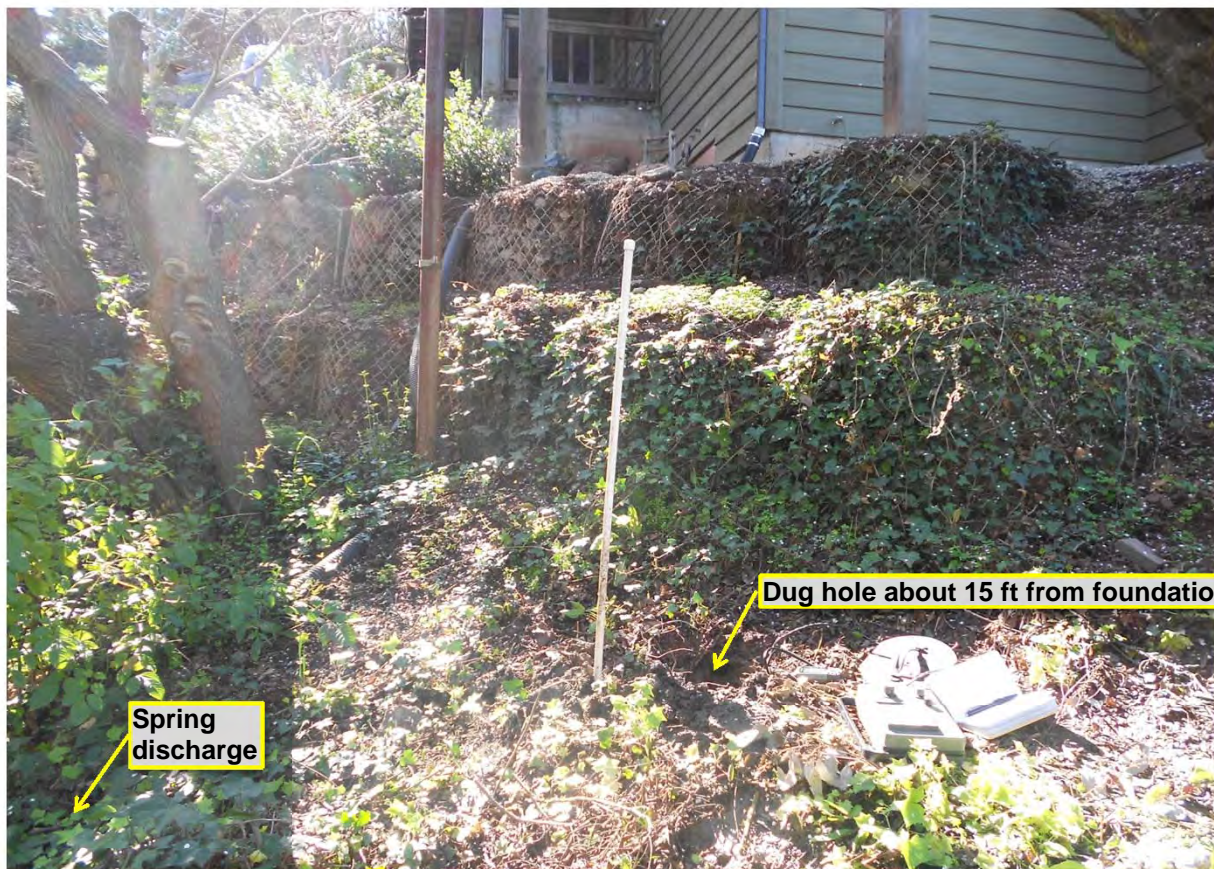
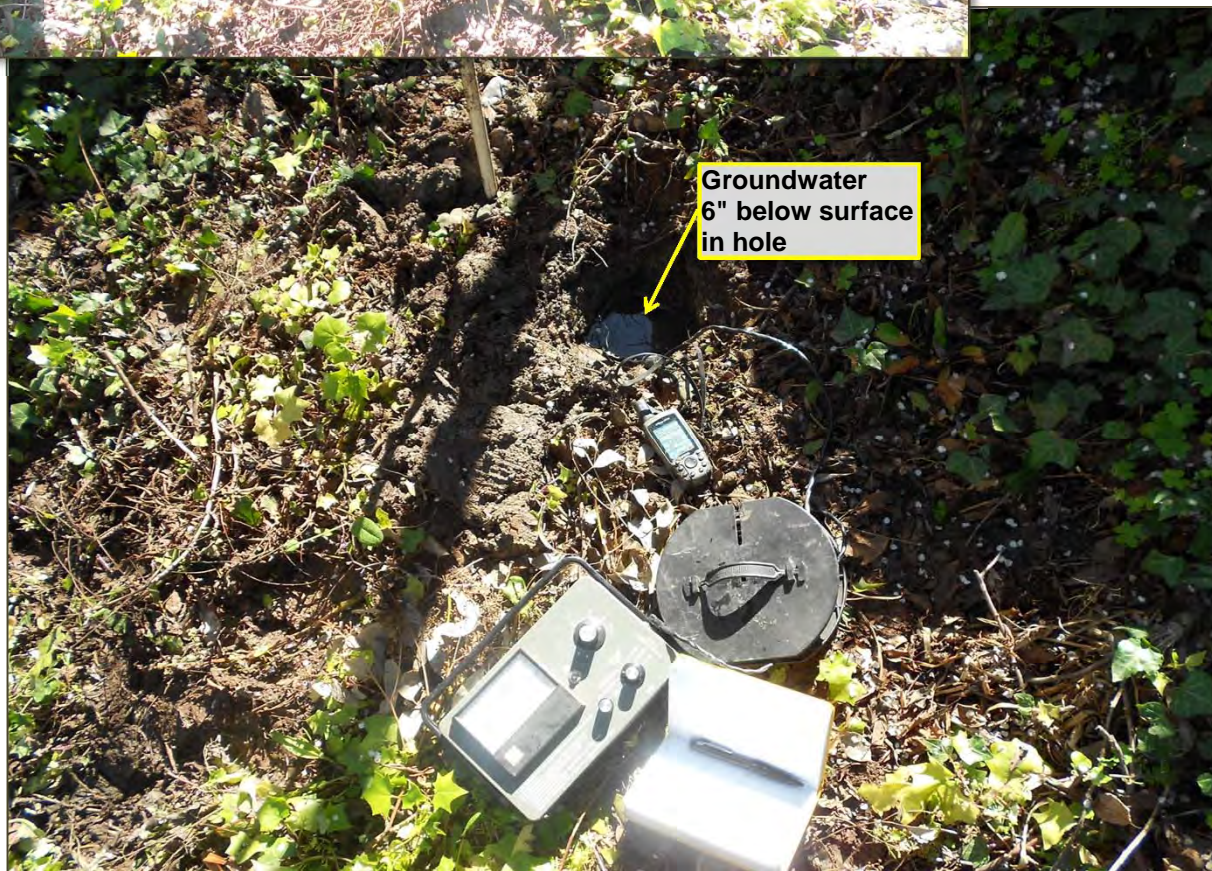
Figure 4. Shallow groundwater on February 13, 2014 at property line of Enea/Charlebois parcel, APN 051-022-180, Redwood City, California. Spring discharge starts just off the photo and near-surface groundwater is found along property line.

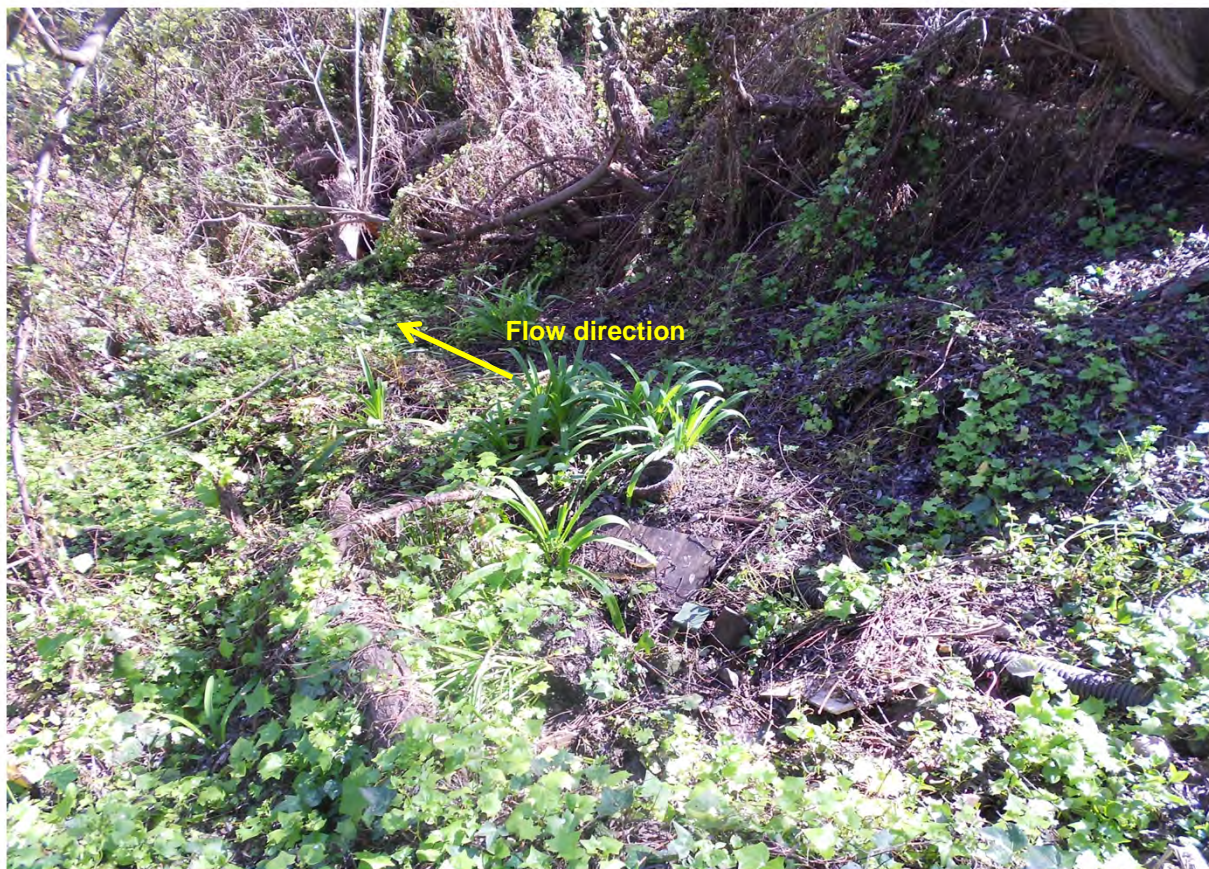
Upper portion of spring

Figure 5. Spring discharge on February 13, 2014 at APN 051-022-310, Redwood City, California. Spring discharge collecting in the asphalt ditch of Los Cerros Road was estimated at less than one gallon per minute.

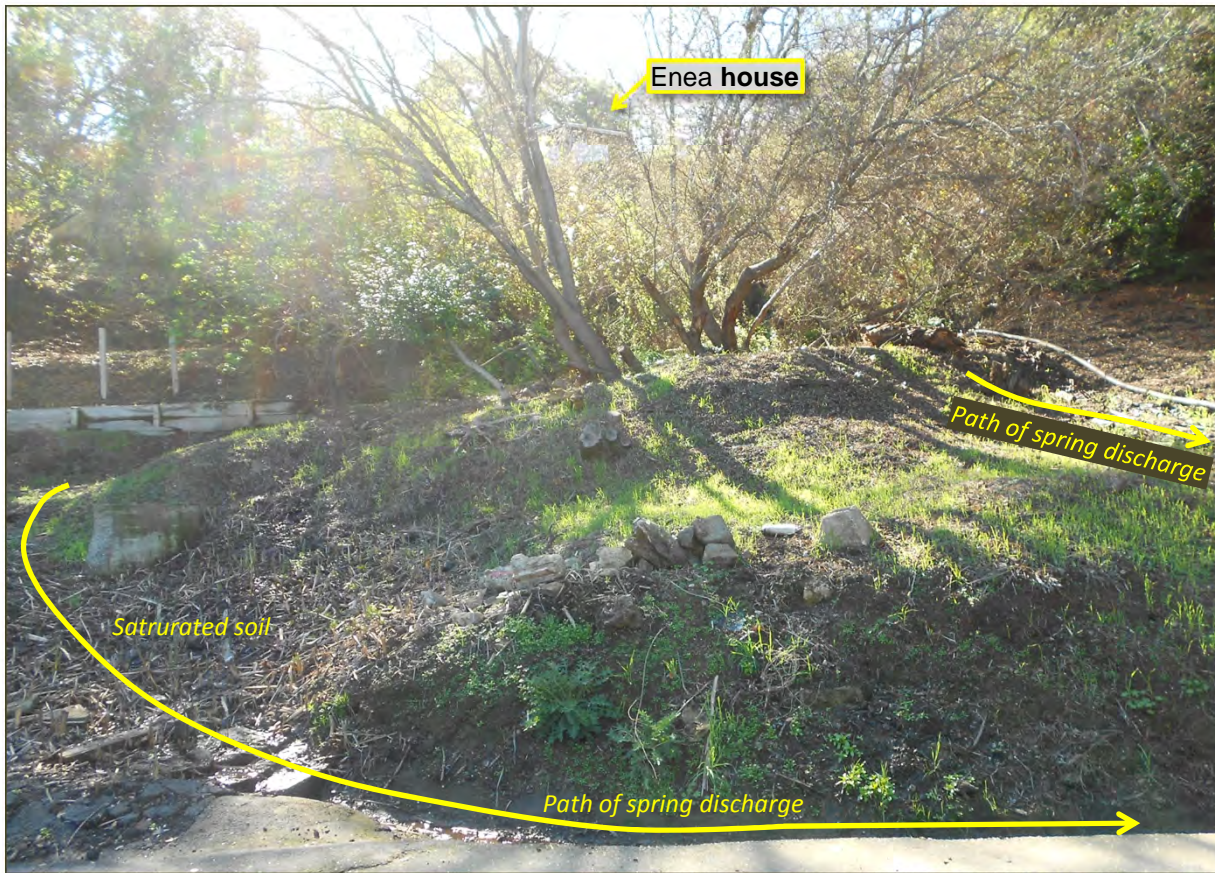
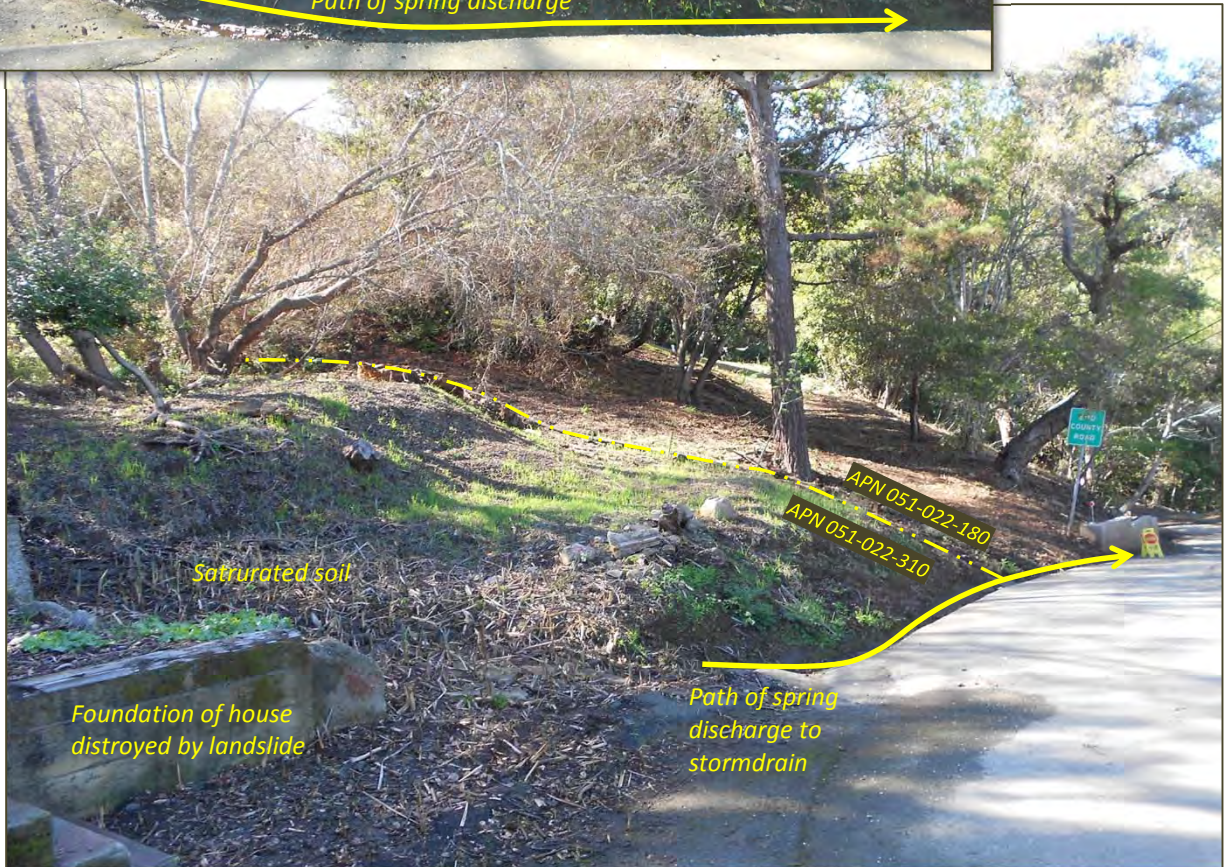
Figure 6. Lower portion of spring on APN 051-022-310, Redwood City, California. Groundwater discharges at the upper portion of the parcel and flows downslope to a ditch along Los Cerros Road.

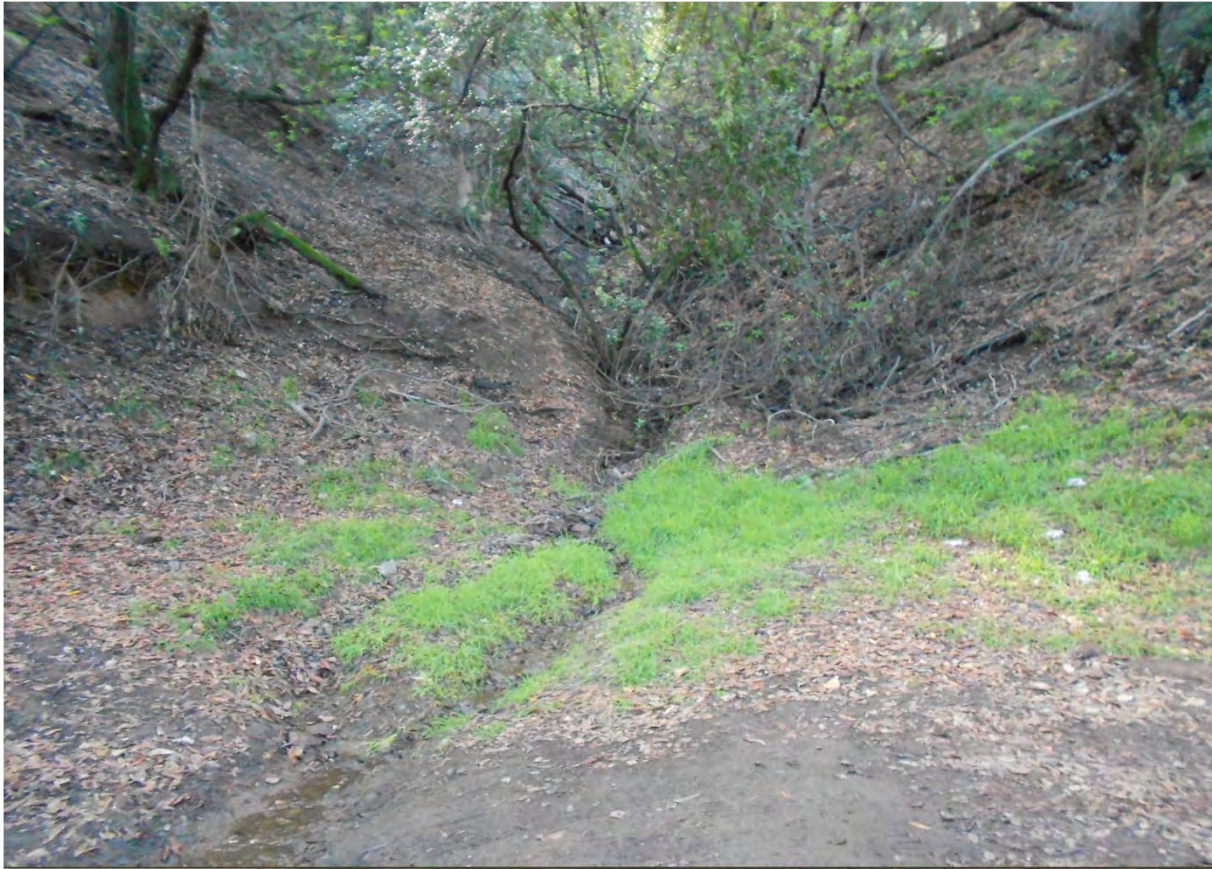
Canyon stream west of Enea / Charlebois property above Los Cerros Rd.

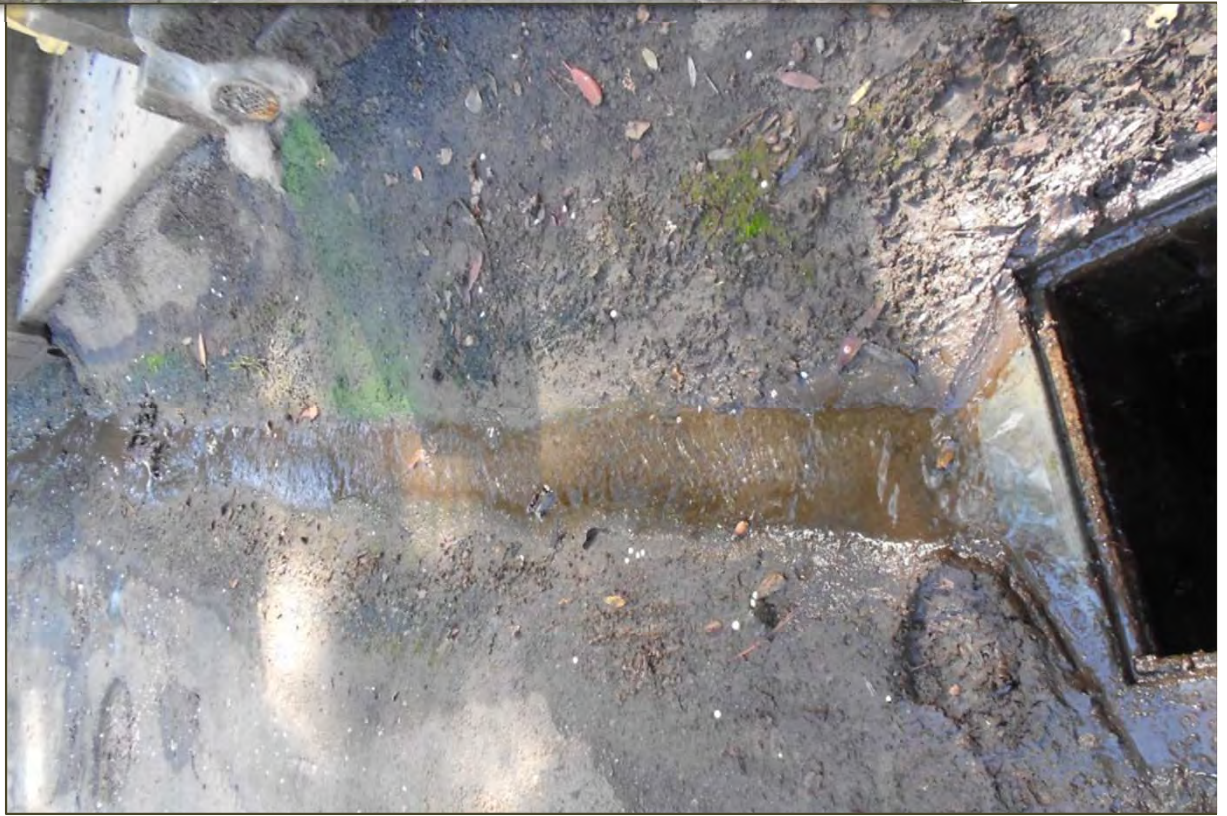
Drainage on Los Cerros Rd. from spring

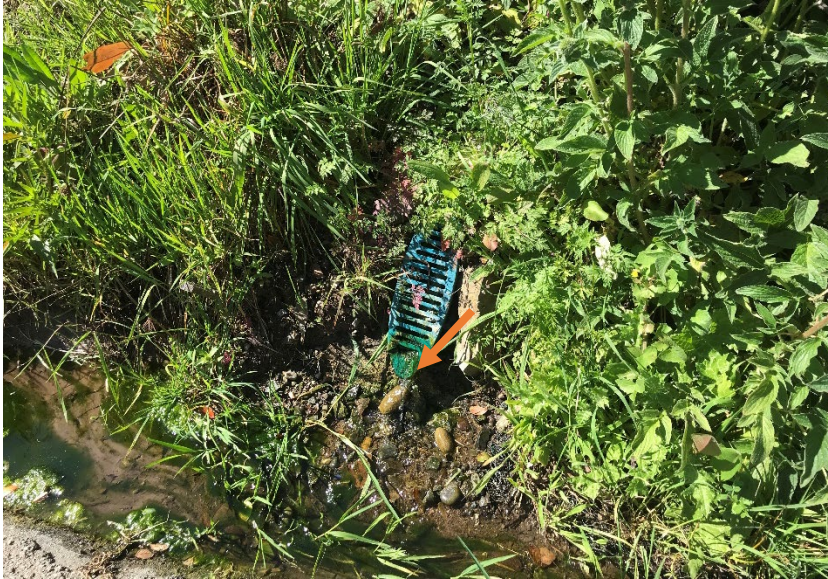
PHOTO 4:
Spring pipe at bottom of landslide area: constant spring water flow

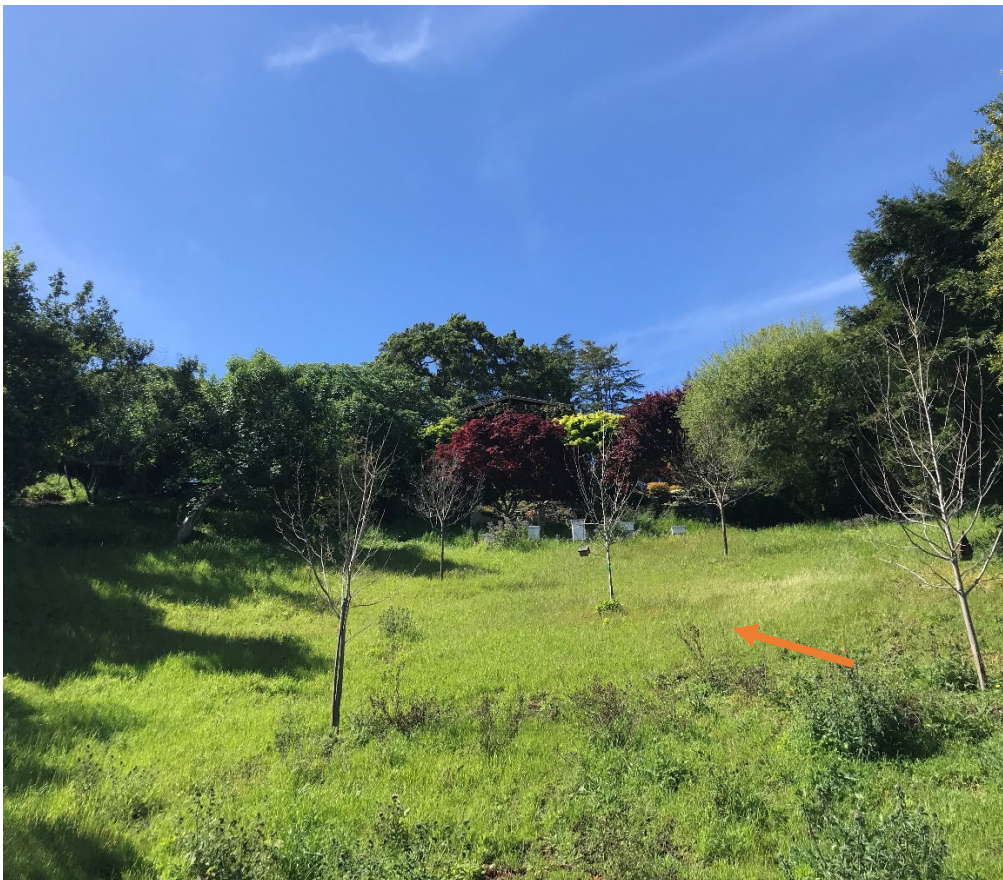
PHOTO 7:
Repaired landslide area
